OPERATING EXPERIENCE WEEKLY SUMMARY

Office of Nuclear and Facility Safety

April 23 - April 29, 1999

Summary 99-17

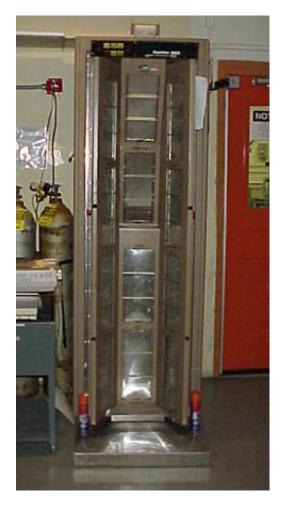
Figure 1-3. PCM-1B Personnel Contamination Monitor

It became evident to health physics personnel that PM-7s detected the particle on the shoe and that PCM-1Bs did not. They conducted a test by attaching a small check source to the side of a shoe and placing the shoe on the PCM-1B foot plate to simulate the actual condition. They found that the PCM-1B failed to alarm if they placed the edge of the shoe snugly against the wall of the foot plate, while the PM-7 alarmed in all cases. To correct the PCM-1B problem, facility personnel, in consultation with Eberline (the manufacturer), installed a spacer bar against the wall of the foot plate of each of the PCM-1Bs (see figures 1-1, 1-2, and 1-3). This prevents a shoe from being placed too far beyond the outside edge of the detector holes in the foot plate.

Investigators determined that the direct and root causes of the contamination event involving the cobalt-60 particle were legacy contamination. Before a comprehensive radiological controls program was implemented in the early part of this decade, discrete particles of cobalt-60 had been dispersed within the HFBR facility. A major cleanup of the facility in 1990 removed the vast majority of the particles. However, legacy particles have not been eliminated altogether. Investigators believe the reactor operator probably picked up a legacy particle when he worked on the equipment level. They also determined that the problem with the PCM-1B was a contributing cause of the event. Corrective actions included continuation of the HFBR's aggressive contamination control program and the installation of a spacer bar on the foot plate of the PCM-1Bs.
